Analysis of Selected Motor Event and Starting Reports

Derrick Haas, Jason Young, and Ryan McDaniel
Schweitzer Engineering Laboratories, Inc.

Originally presented at the
65th Annual Conference for Protective Relay Engineers, April 2012

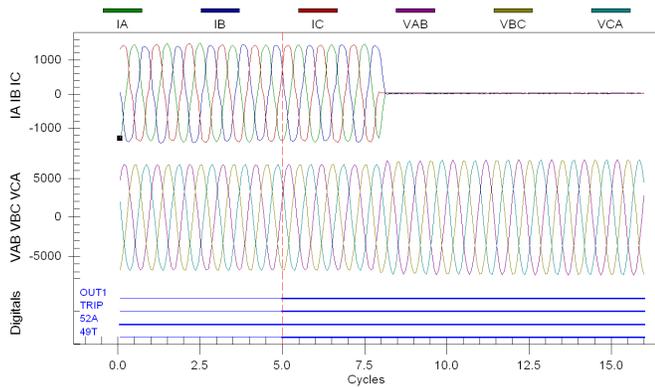
Fig. 1. Event report from a microprocessor-based relay showing a trip on thermal overload

We can see from the oscillograph that the currents appear to be balanced. This machine has a rated full-load amperes of 333 A. The current magnitude shown in Fig. 1 is approximately 4.4 times the rated current. In addition, the 49T bit is an indication that the relay thermal overload protection called for the trip.

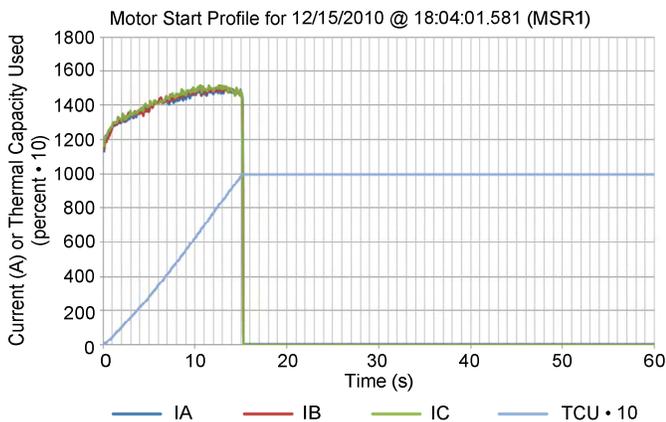
Because the event report alone in this case is not enough to pinpoint the problem, several motor start reports were retrieved from the microprocessor-based relay. This particular relay stored start reports from the last five motor starts. The latest motor start report is shown in Fig. 2. The current magnitudes for A-, B-, and C-phase currents and the thermal capacity used (TCU) are plotted against time. The abrupt drop in current to zero at approximately 14.8 seconds after the motor start was attempted gives us further confirmation that the relay tripped on thermal overload.

Fig. 2. Motor start report data for the most recent start

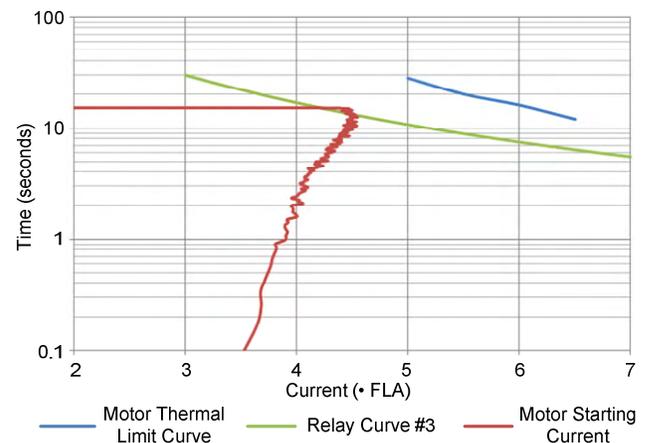
Fig. 3. Motor starting current, relay trip characteristic, and hot thermal damage curve on the plot of time versus current

Based on (1), (2), and Fig. 3, we can assert that the relay operated consistently with the published trip characteristic and the settings. So why did the relay trip? Were the curve settings set too fast? Could an adjustment to the relay curve setting be the solution?

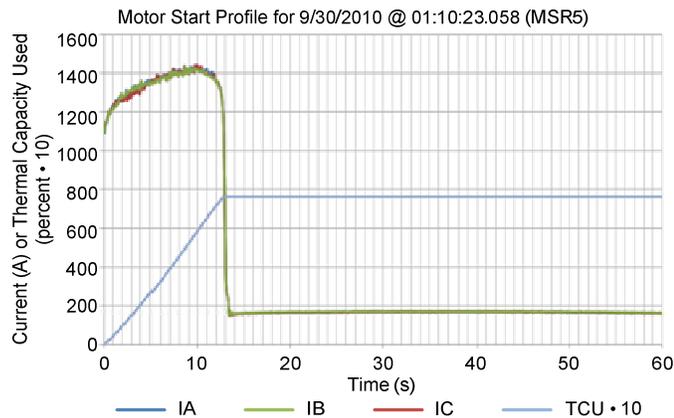
After talking to the electricians, the motor had started fine in the past with the same settings. Several of the older motor start reports had recorded successful starts. Fig. 4 is a plot of a motor start report from September 2010 showing a successful start. It is important to note that the motor took only approximately 13.3 seconds to start and the maximum starting current was 1,446 A or 4.3 per unit. So the duration of the start and the peak current magnitude were both smaller for the successful start in September.

Fig. 4. Motor start report data for a successful start in September

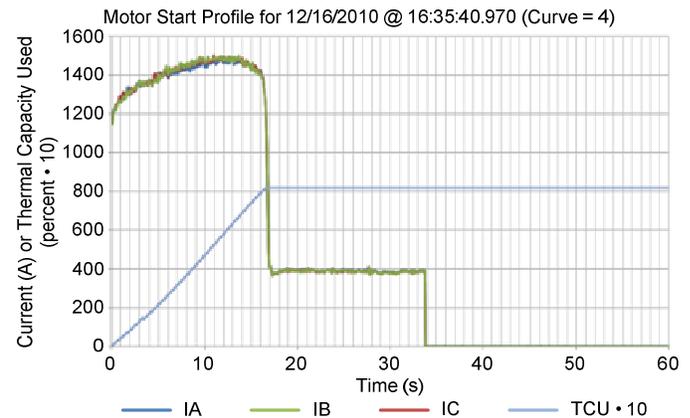
Fig. 5. Motor start report for a start after changing the curve setting to 4

We notice that this time the motor did come up to speed. However, if we look carefully, the running current is approximately 400 A. This is 1.2 times the rated full-load value of the motor. The machine was stopped. What changed?

thermal protection of the motor and would perhaps allow enough time for the motor to start. The relay setting was changed, and a motor start was attempted. The resulting motor start report is shown in Fig. 5.

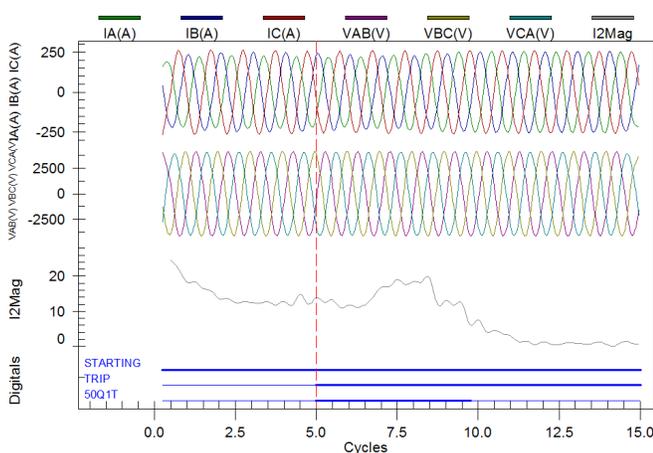
From the relay event report shown in Fig. 7, we can see that the 50Q1T element caused the trip. From the previous settings, we know that this element is set to operate when the negative-sequence current (3I2) is greater than half of the full-load amperes (FLA1), or 19.5 A primary.

Fig. 7. Initial unbalance trip

Fig. 7 shows that the I2 magnitude at the time of the trip was approximately 12 A primary. This means that 3I2 was approximately 36 A primary and well above the pickup threshold of 19.5 A primary. However, the event report also shows that less than 5 cycles after the trip was issued, the

One reference recommends that a definite-time element operating on negative-sequence current be set at 1.5 A secondary with a 4-second delay to ride through the saturation that can occur during a start. This setting ensures the security of the element [5].

This case also highlights the value of event report analysis. Had the users looked at the event report after the initial trip, they would not have spent time rolling wires and would have modified the settings, thus reducing the downtime caused by the event.

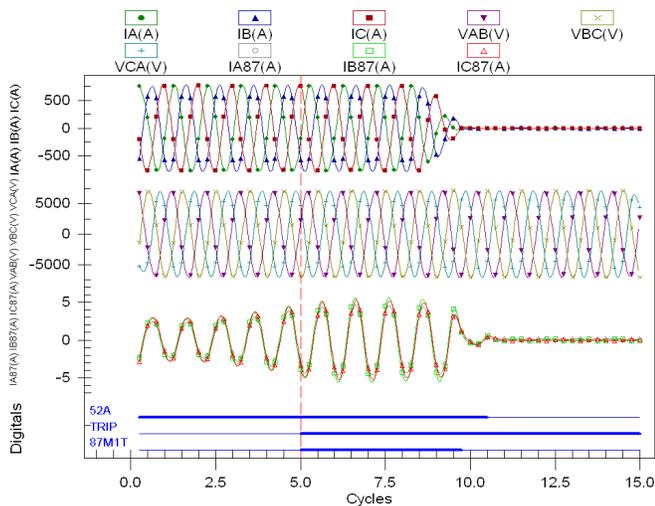
There is no set time delay; however, the pickup is larger than some of the settings recommendations discussed in the previous paragraph. The microprocessor-based relay event report data for the trip are shown in Fig. 9. We can see that the currents and voltages appear very balanced and below the full-load ampere rating of the motor. In addition, we see approximately 5 A secondary of differential current just as the relay tripped. Also noteworthy is that all three differential currents (87A, 87B, and 87C) are almost perfectly in phase with roughly equal magnitudes, indicative of zero-sequence current.

Fig. 9. Filtered event report of a differential trip

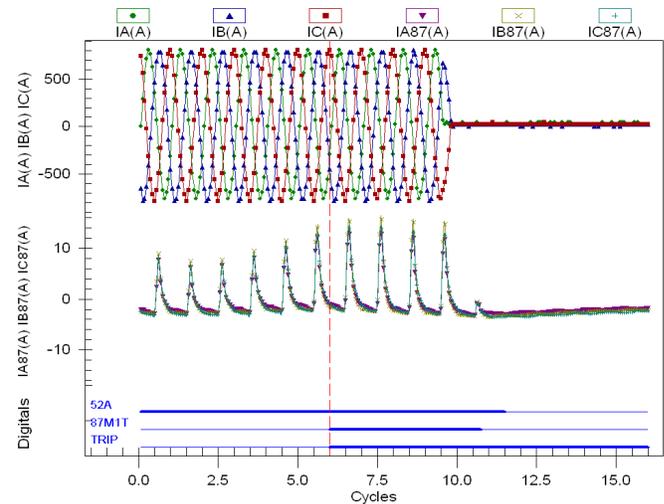
In addition, the raw, unfiltered event data are shown in Fig. 10. We can see how the relay digital filtering processed the distorted current signals.

Fig. 10. Raw event report of a differential trip

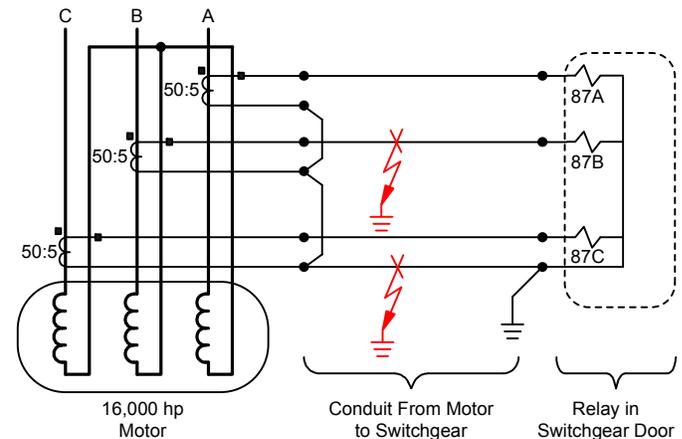
When the relay and primary equipment are tested and appear to be functioning as expected, the next logical place to check is the secondary wiring. After the insulation to ground on the secondary wiring was checked, two wires were found to have developed short circuits to ground. The locations of the ground faults are shown in Fig. 11. Both were located in the metallic conduit between the switchgear and the motor location. All wiring in this metallic conduit was replaced.

Fig. 11. Simplified three-line diagram with short-circuit locations shown

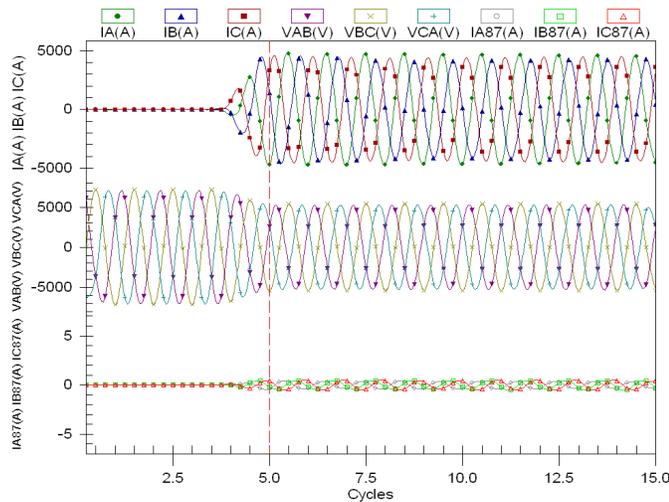
After correcting the issues with the secondary wiring, the motor was started with no resulting trip. The oscillograph from the successful start is shown in Fig. 12. Note that the differential current is greatly reduced, now less than 0.5 A secondary.

Fig. 12. Filtered event report from a successful start

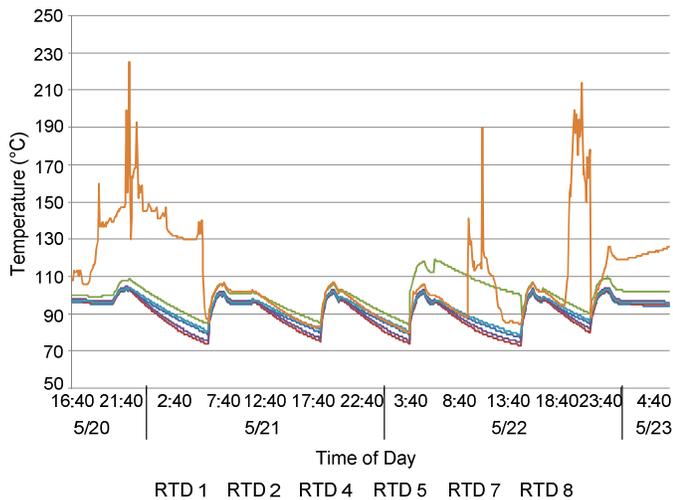
Fig. 13. RTD temperature versus time

We notice that RTDs 1 through 7 trend together and match reasonably well. However, RTD 8 exhibits erratic behavior at

After further investigation, a loose connection on the RTD 8 circuit was found. This particular relay RTD diagnostic algorithm declares an open circuit when the measured temperature is above 250°C. Because the connection was not a true open circuit but simply a loose wire, the impedance (and hence temperature) never exceeded the threshold.

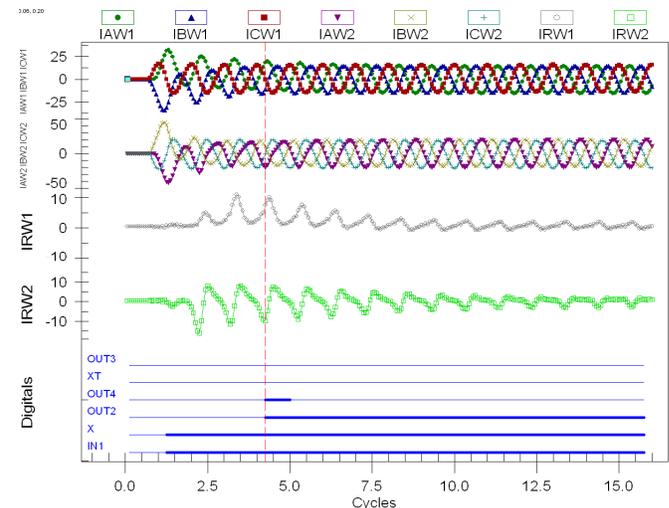
The oscillograph from the filtered event report is shown in Fig. 14. Notice how the ground currents are not sinusoidal and decay throughout the event report. Whenever we see ground current that decays, it is an indication that CTs may be saturating.

Fig. 14. Filtered event report of the phase differential trip

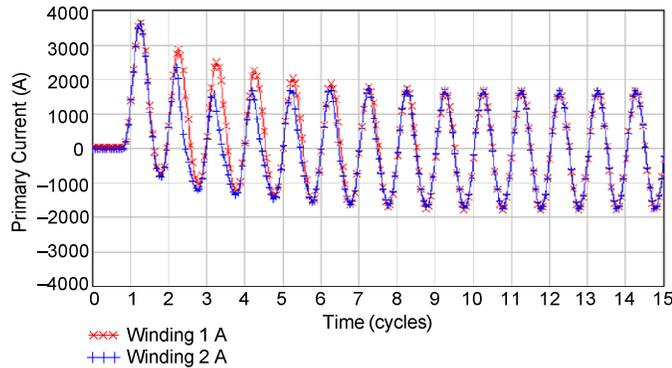
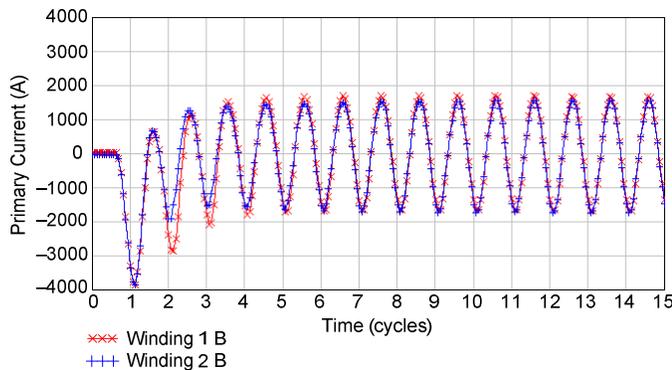
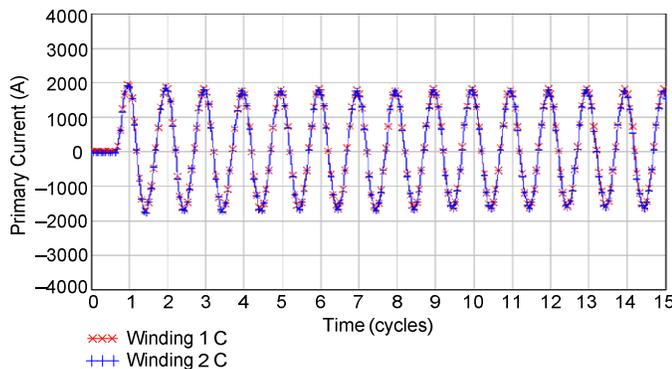
Fig. 15. A-phase Winding 1 and Winding 2 currents

Fig. 16. B-phase Winding 1 and Winding 2 currents

Fig. 17. C-phase Winding 1 and Winding 2 currents

Note that for the C-phase currents, the Winding 1 current and Winding 2 current in Fig. 17 almost match. However, for A-phase and B-phase in Fig. 15 and Fig. 16, we notice that the Winding 2 currents experience saturation. The two sets of CTs

The ultimate solution for this particular problem is to replace both CTs during the next scheduled outage so that they have identical CT ratios, ANSI ratings, and saturation characteristics. In the meantime, the slope settings were adjusted to ensure security during starting and to avoid the nuisance targeting that was a result of the previous timer scheme.

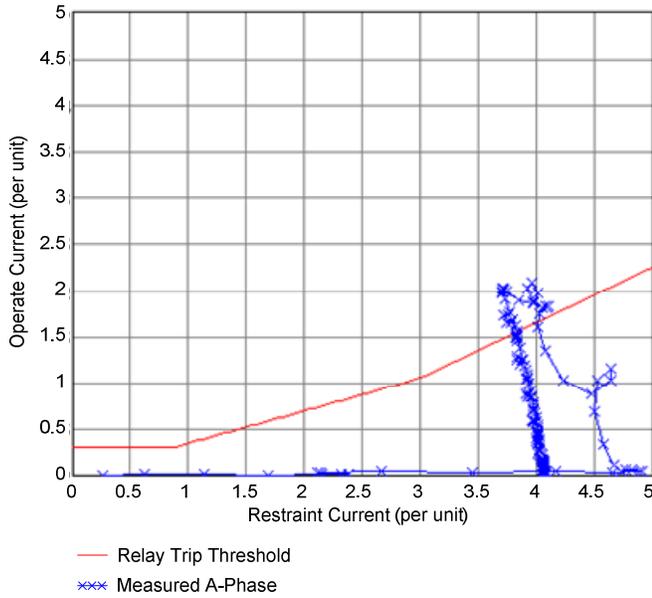
The measured operate and restraint currents shown in Fig. 18 cross the trip threshold. The settings were SLP1 at 35 percent, SLP2 at 75 percent, and IRS1 at 3 per unit. If we adjust the settings so that SLP2 equals 75 percent and IRS1 equals 1.8 per unit, the relay will restrain. Fig. 19 shows the relay response with both the original and new threshold settings.

Fig. 18. Relay trip threshold and measured current with the original settings

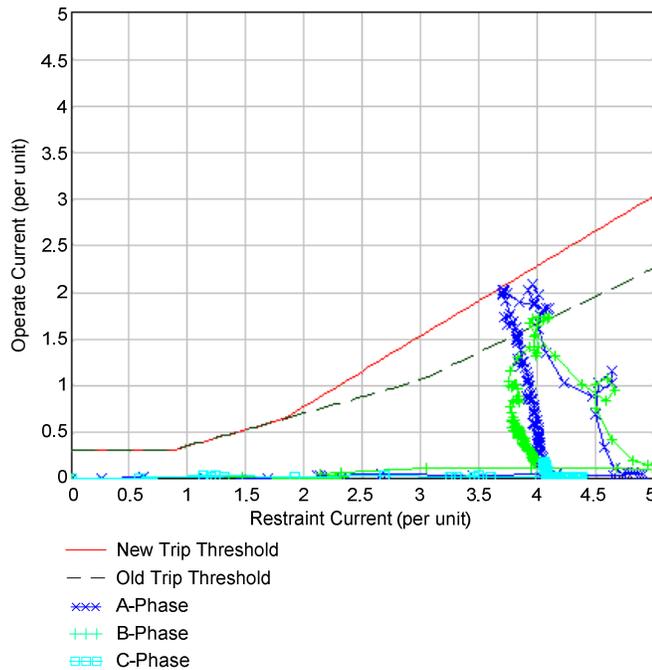
Fig. 19. Relay trip threshold and measured current with the original and new settings

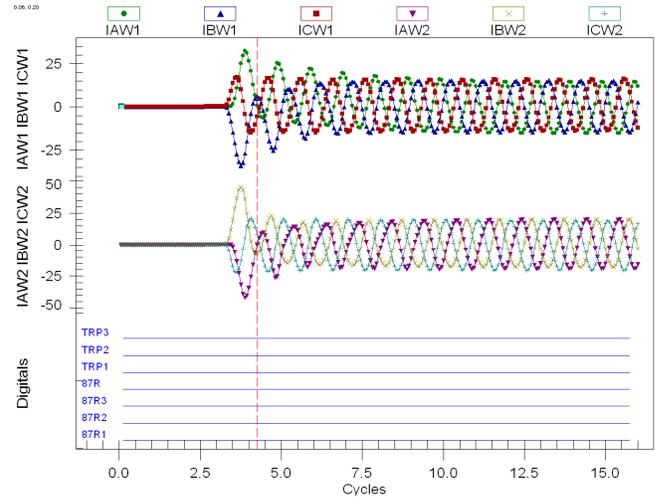
Fig. 20. Raw event report from the replayed event with the new settings

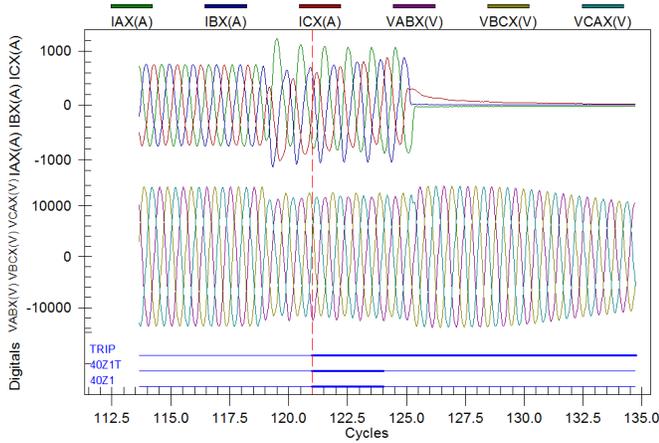
As is common for synchronous motor installations, a generator relay was installed in parallel with the main motor protection relay to provide field-related protection. At the time of the start, the generator relay tripped the synchronous motor on a loss-of-field element. The event report from the trip is shown in Fig. 22.

Fig. 22. Loss-of-field trip

The solution to the problem is that the generator relay is expecting both CTs to be connected with opposite polarity to this installation. Reversing the polarity of both sets of CTs causes the relay to correctly read the current values and prevents operation of the loss-of-field relay if these circumstances occurred again.

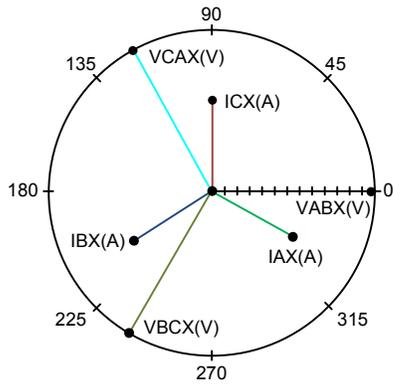
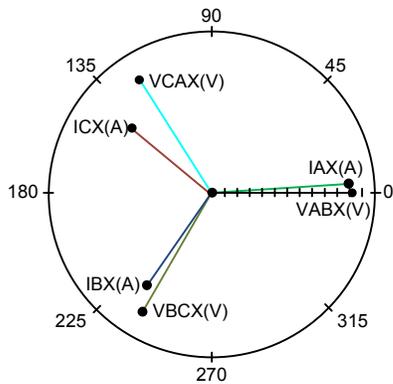
Fig. 23. Normal load phasors

Fig. 24. Loss-of-field event phasors

By design, a generator relay defines positive power (both real and reactive) to be out of the generator. As can be seen in Fig. 23 and Fig. 24, the relay is calculating forward power, indicating that power is flowing into the system. However, because the relay is applied to a motor, we know that the opposite is true, leading to the conclusion that the CTs should be connected with the reverse polarity.

Fig. 24 also indicates that VARs are flowing into the machine, which appears to be a loss-of-field condition. However, during the start of the adjacent motor, the bus voltage dropped. Because VARs flow toward the lower voltage, they are actually flowing out of the motor. Therefore, the VARs are actually flowing out of the machine, but the relay thinks they are flowing into the machine.

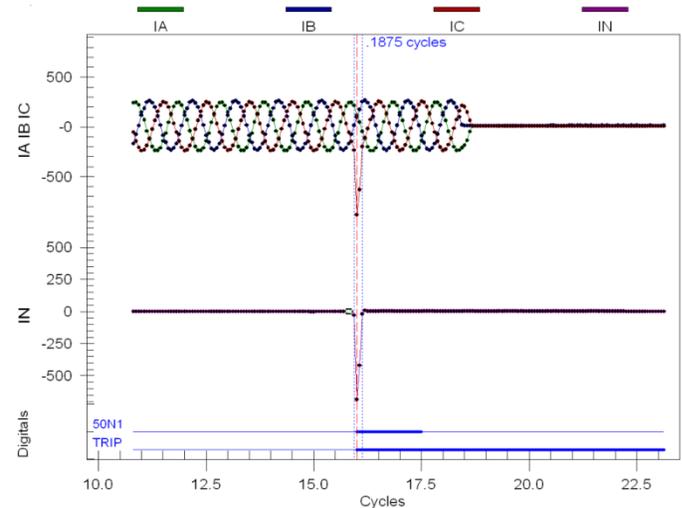
Fig. 25. Relay A event capture

The 50N element, which called for the trip, was set to 400 A primary. The event indicates a spike of about 1,248 A (peak) for a very short duration. It is the short duration of fault current that is puzzling. In general, once a fault starts, it does not finish on its own, and the opening of a breaker is required to clear the fault. While the breaker did open 2.67 cycles after the spike, the fault extinguishes prior to the opening of the breaker.

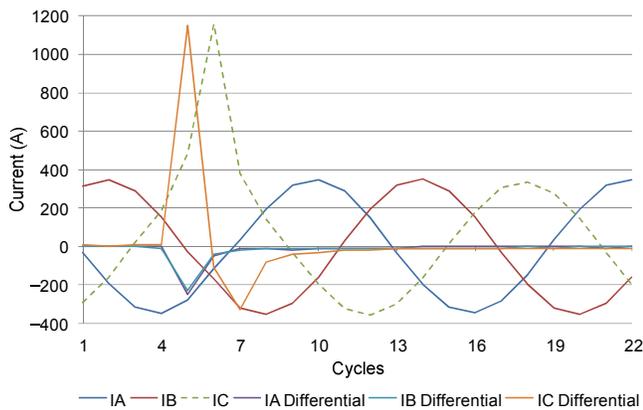
Fig. 26 shows a portion of the unfiltered event captured by Relay B. Again, we can see that the C-phase currents (dashed line) spike to about 1,200 A (peak). In addition to the C-phase current, we also have the C-phase differential current, which is the current from the flux-balancing CTs located in the junction box of the motor. The C-phase differential current also shows a very large and abrupt increase in current.

Fig. 26. Relay B event capture

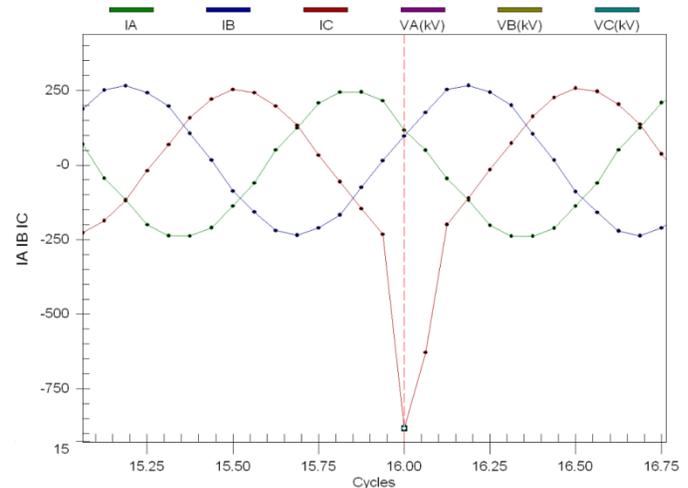
- Digital relays have numerous safeguards to prevent erroneous data from occurring, including relay self-tests.
- For this particular event, Fig. 27 shows that two sequential measurements on C-phase of Relay A (each dot is a sample) are very high compared to pre- and post-event data. This further supports that the relay is in fact measuring a real event.
- Not only is the spike seen on C-phase, but it is also seen at the same time on the IN channel, which is a separate analog channel that is measured by the relay. Also, the magnitudes are similar.

Fig. 27. Zoomed Relay A event capture

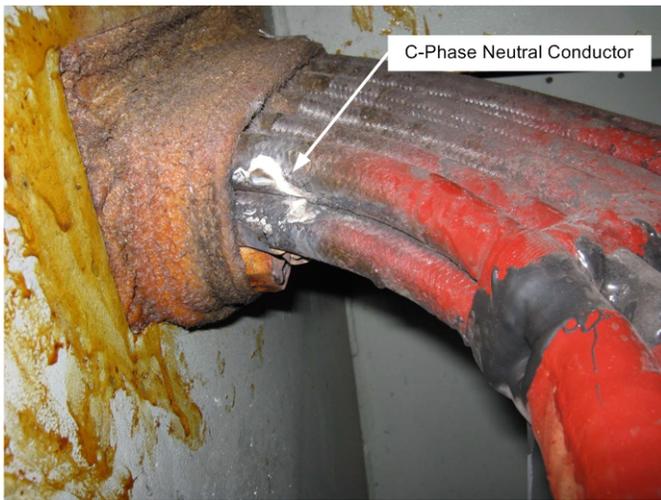
Based on the fault current values seen during the event, closer inspection was given to the source side of the stator winding. This includes the junction box where the phases are landed on the motor terminals. The two conductors in the foreground are paralleled neutral conducts, and these show a sign of possible arcing (see Fig. 29). The two paralleled conductors just behind are the C-phase incoming conductors.

Fig. 29. Side view of the incoming and neutral conductors

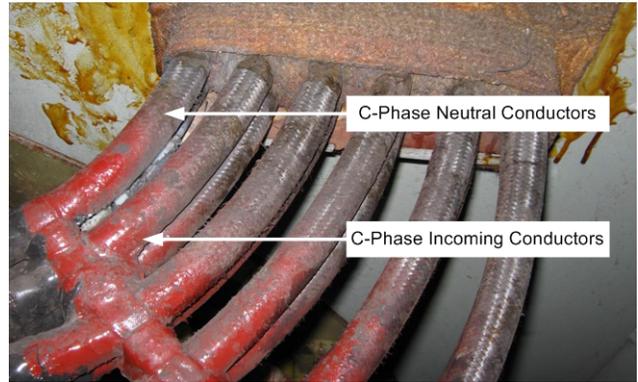
Once the external arcing was seen on the neutral, the wrapping around the incoming C-phase conductors was removed to reveal the silicon jacket. This revealed apparent tracking from a fault and showed the silicon jacket eroding. Based on the length and trajectory of the marks, it is apparent that moisture ingress led to the breakdown of insulating material. Fig. 31 shows the tracking marks in the incoming C-phase line.

Fig. 30. Top view of the incoming and neutral conductors

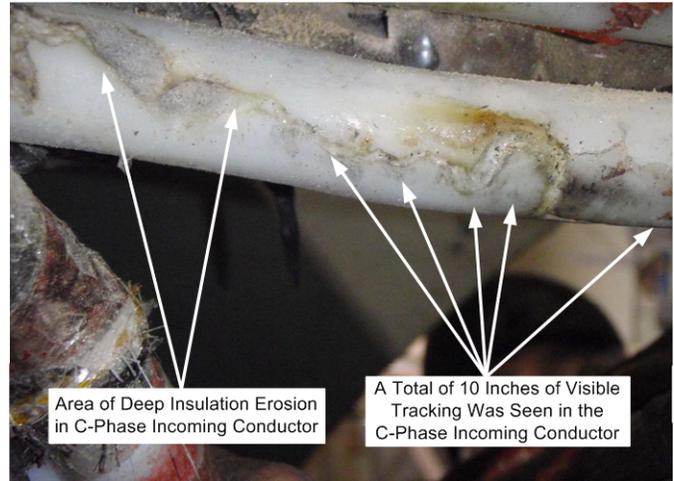
Fig. 31. C-phase incoming conductor damage

At this point, we have clearly found an insulation breakdown on the C-phase incoming conductors and tracking on the neutral conductor. However, a connection between the incoming C-phase and neutral would not produce fault currents but a motor unbalance condition. What about that burn mark that was found on-site?

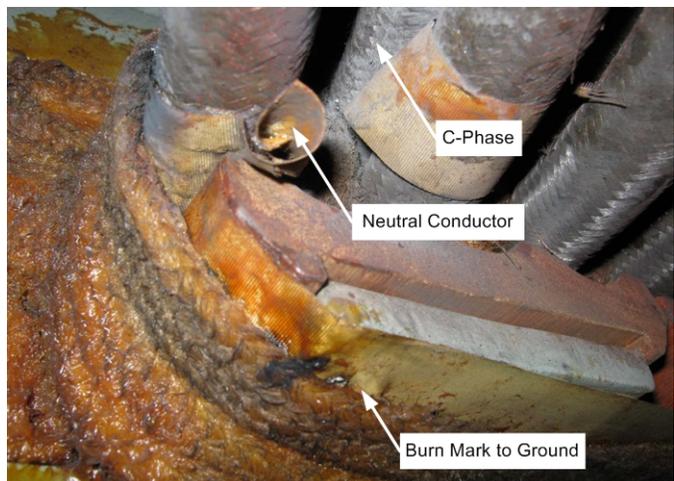
Fig. 32 shows a very tiny burn mark that is very close to the neutral and C-phase tracking. This is the path for C-phase to ground and led to the large amount of current seen.

Fig. 32. Ground point

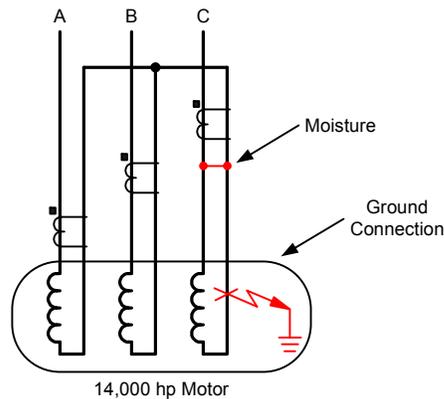
This particular fan was located between two areas with large temperature differences that led to condensation forming in the motor. This condensation gathered at the bottom of the motor housing and found a way to seep into the conductors, which eventually broke down the insulation. With the insulation breakdown and a supply of water running near the C-phase conductor, the dielectric strength between C-phase and ground broke down and allowed a temporary flashover. Fig. 33 shows an electrical diagram of the fault.

Fig. 33. Electrical representation of the fault
