Analysis of Selected Motor Event and Starting Reports

Derrick Haas, Jason Young, and Ryan McDaniel
Schweitzer Engineering Laboratories, Inc.

Originally presented at the
65th Annual Conference for Protective Relay Engineers, April 2012

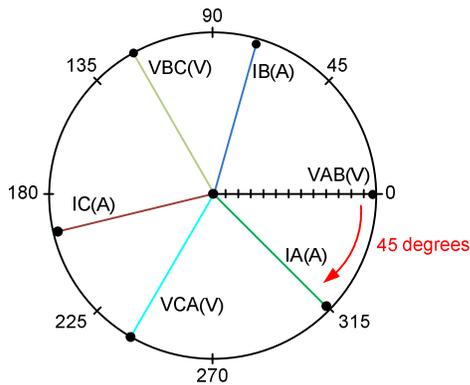
Fig. 6. Motor start phasor relation

In April 2010, a 375 hp motor suffered an unbalance trip while starting. It was assumed that two current transformer (CT) secondary wires were rolled going to the relay. Therefore, the A- and C-phase wires were swapped in an attempt to correct the assumed problem, and the motor was started again. Despite the wiring change, once again, the relay tripped on unbalance. Assuming the wrong wires had been swapped, the B- and C-phase wires were rolled and the motor was started for a third time, and the relay tripped on unbalance for the third time.

The motor was applied to an ACB system. Fig. 6 shows the phasor relation from the initial trip. As expected, the phase current lags the phase-to-phase voltage by approximately 45 degrees.

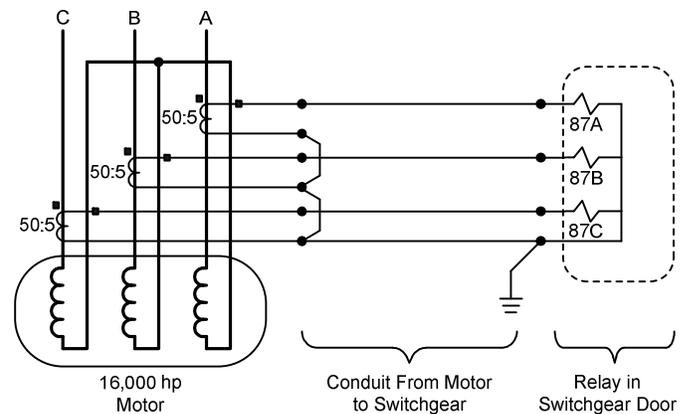
Fig. 8. Simplified three-line diagram

In November 2010, a 16,000 hp motor tripped during starting from a current differential fault. The particular motor installation made use of a self-balancing differential scheme. This scheme is applied where access to all six motor leads is available. A simplified three-line diagram of the installation is shown in Fig. 8.

When the relay and primary equipment are tested and appear to be functioning as expected, the next logical place to check is the secondary wiring. After the insulation to ground on the secondary wiring was checked, two wires were found to have developed short circuits to ground. The locations of the ground faults are shown in Fig. 11. Both were located in the metallic conduit between the switchgear and the motor location. All wiring in this metallic conduit was replaced.

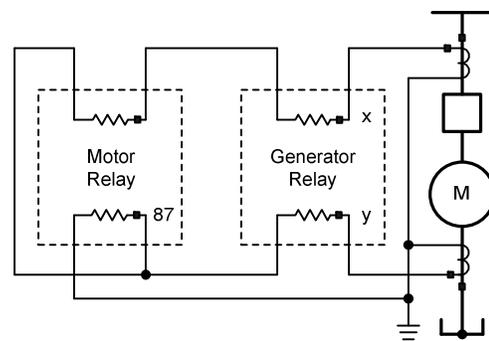
Fig. 21. 25,000 hp synchronous motor one-line diagram

In July 2011, a 25,000 hp synchronous motor was tripped by a loss-of-field relay. The motor was in service when an adjacent motor was started. The connections were as shown in Fig. 21.

As is common for synchronous motor installations, a generator relay was installed in parallel with the main motor protection relay to provide field-related protection. At the time of the start, the generator relay tripped the synchronous motor on a loss-of-field element. The event report from the trip is shown in Fig. 22.

Fig. 24 also indicates that VARs are flowing into the machine, which appears to be a loss-of-field condition. However, during the start of the adjacent motor, the bus voltage dropped. Because VARs flow toward the lower voltage, they are actually flowing out of the motor. Therefore, the VARs are actually flowing out of the machine, but the relay thinks they are flowing into the machine.

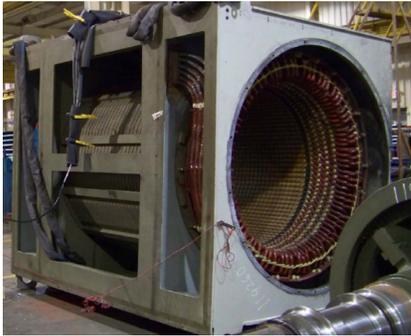
Fig. 28. 14,000 hp ID fan motor

Once the motor was taken out of service, the search began to visually inspect it for signs of a fault. The bell ends were removed on-site for a visual inspection of the stator winding. A burn mark was found in the motor end box near the neutral point of the stator. No other damage was seen. A burn mark does not explain elevated fault current seen by the relays because a fault to ground at the neutral point of the motor would produce no fault current. For reference, it was found through system models that a bolted phase-to-ground fault at the incoming phase terminals of the motor produces 1,200 A of root-mean-square (rms) fault current. We see about 883 A rms during the 0.1875 cycles the fault is present. Based on this information, the burn mark cannot be the only trouble spot in the motor. The burn mark only represents the path the arc took to get to ground; the source of the burn mark has yet to be found.

The motor was shipped to the manufacturer for closer inspection. It was carefully taken apart, and extensive tests were performed. High-potential tests on the windings showed no apparent issues with the winding. Fig. 28 shows a picture of the motor lying on its side, viewed from the nondrive end.
